HISTORIC STRUCTURES REPORT

HISTORIC STRUCTURES REPORT
STRUCTURAL SECTION
PEAVEY PLAZA
MINNEAPOLIS, MINNESOTA

Prepared by: Michael Ramerth, P.E; Elizabeth Kinney, P.E.

July 18, 2016

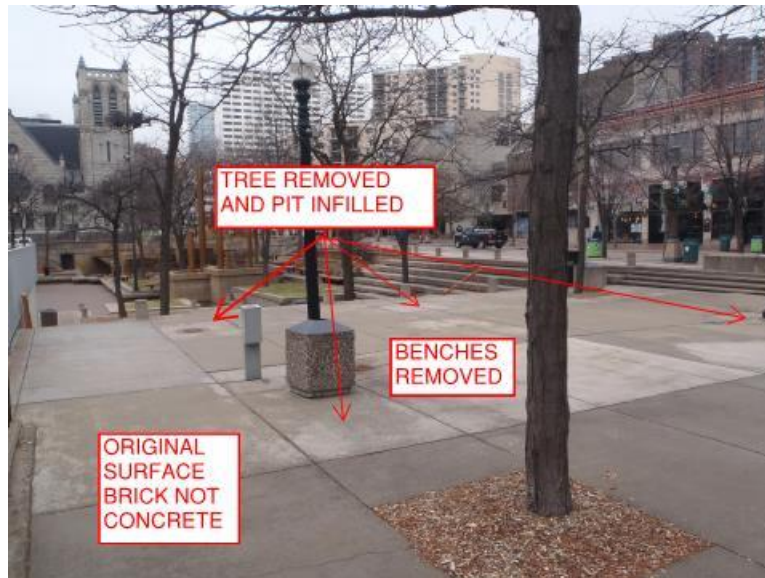
Upper North Plaza: The northern part of the plaza has seen the most changes. The upper plaza that borders 11th street was originally brick pavement, but was replaced with a concrete slab in 1998. Many trees have been removed, and in several locations a tree has been replaced with a lamp post, see photograph 1. Also, a grouping of 9 benches was removed completely in this area.

Photograph 1: North Plaza

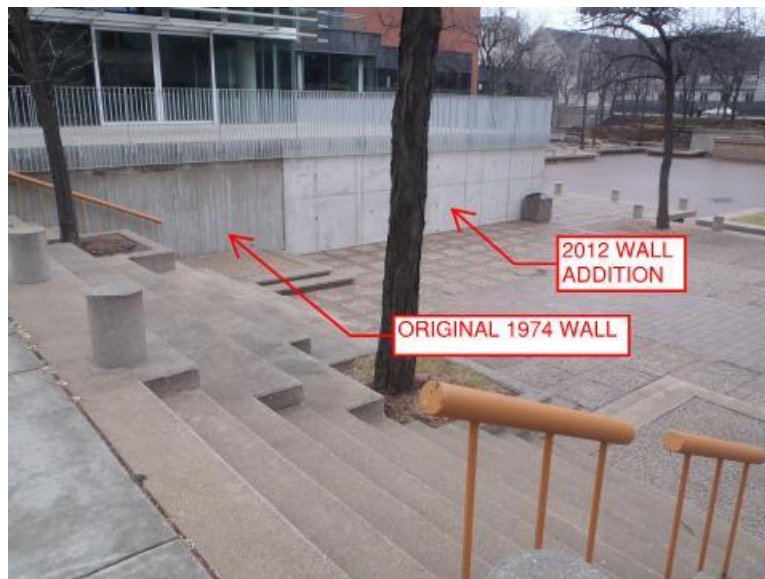
Lower North Plaza: The retaining wall in the north east plaza was original to the 1974 design. IT separated the plaza from the Orchestra Hall building. However, during the addition to Orchestra Hall in 2012 it was partially removed and reconstructed. The northernmost section is original and has a finish that is consistent with the rest of Peavey Plaza. The replacement wall is the southern section and it has a flat finish and is obviously different in character, see photograph 2.

Photograph 2: North Plaza looking south east

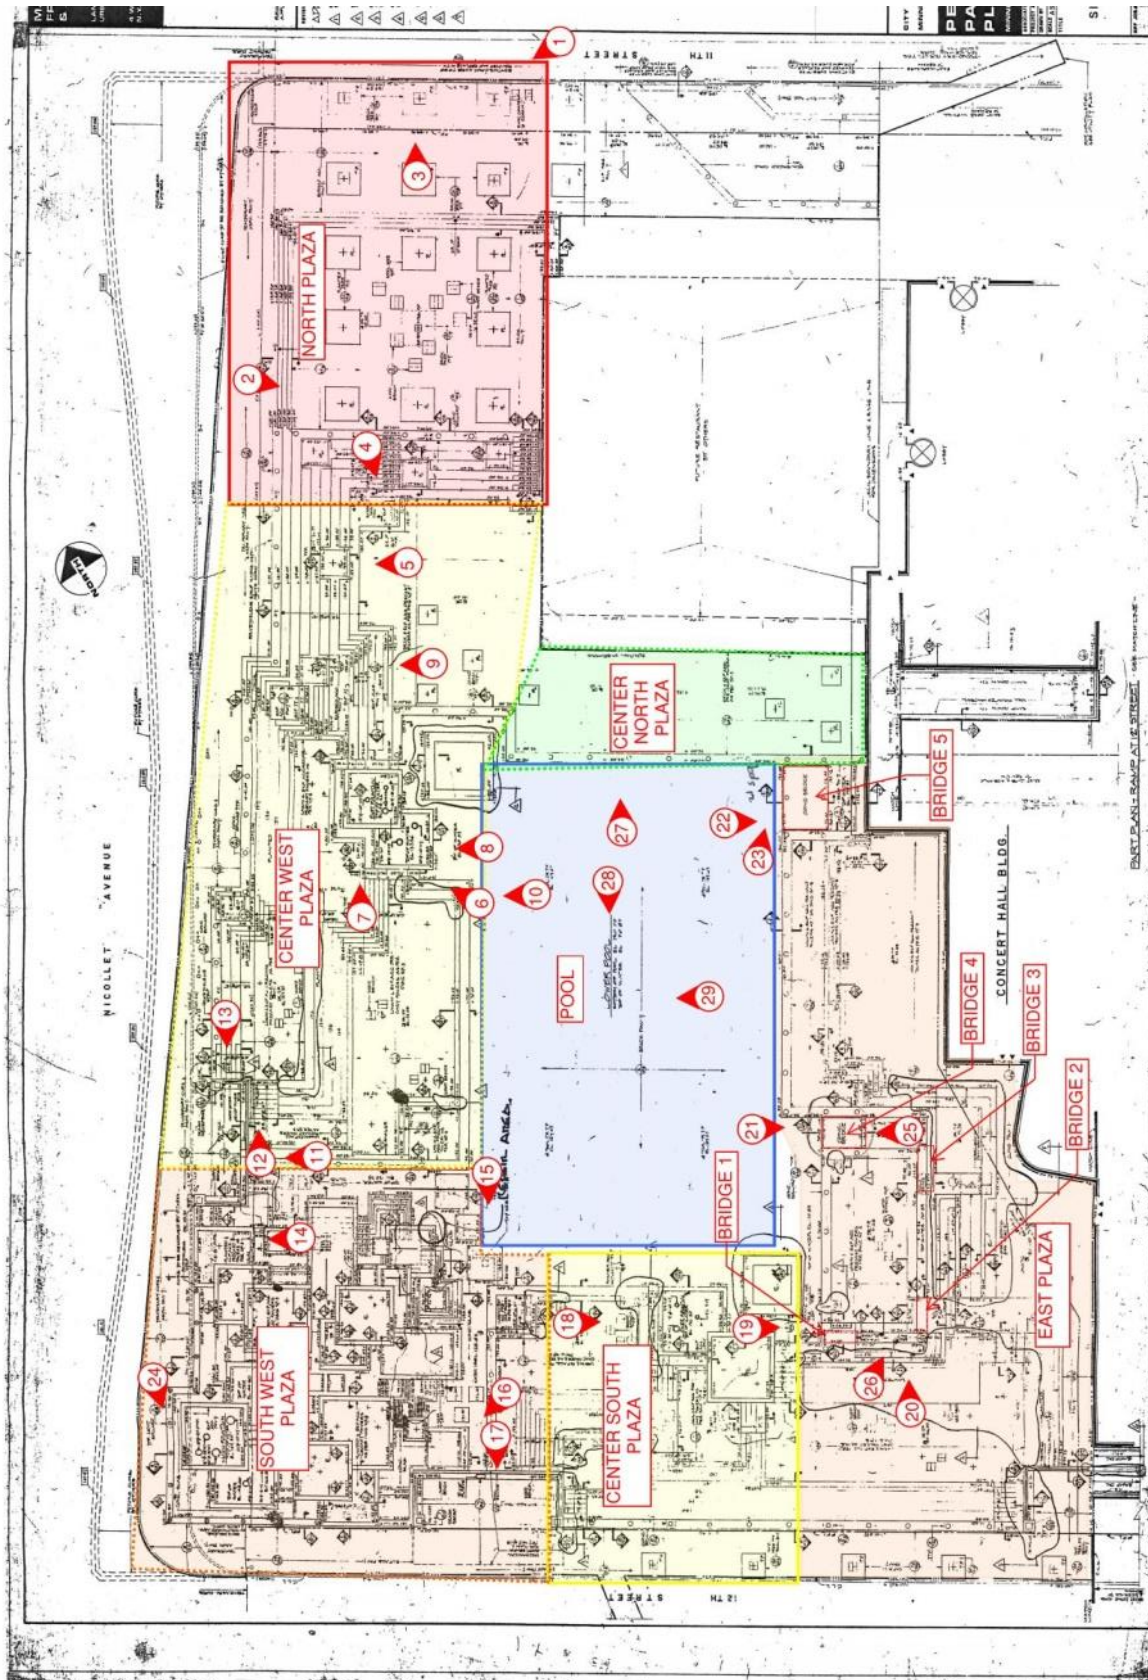
Figure 1: Key plan for lay out of plaza and location of photographs.

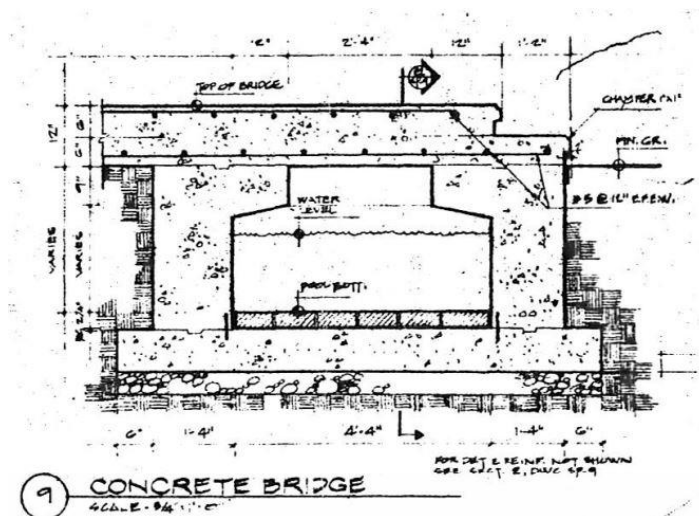
East plaza (along Concert Hall building): This section has five bridges, several of which are in need of repair. Three of the bridges are approximately 4'-4" wide and 10' long, a section through them is shown in Figure 2. There is little clearance under these bridges and visibility was limited, so the full extent of deterioration could not be viewed. The two southernmost bridges, shown as bridges 1 and 2 on the key plan, are in good condition, see photographs 20 and 21. The southwest bridge, shown as bridge 3 on the key plan, still has its plywood formwork in place, so it was not possible to see the condition of the concrete under the slab. The side walls are in good condition apart from the south east support where the corner of the concrete has been damaged and is missing, see photograph 22. It appears that a repair of this area was attempted, but has failed.

Figure 2: Section 9 on SP-9

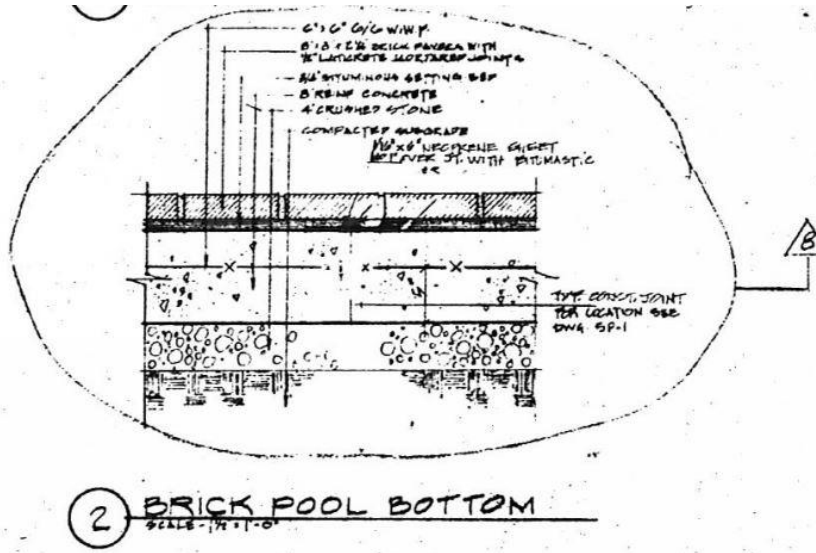
Pool: The brick bottom of the pool is generally in acceptable condition. There is one significant crack running north-south at approximately the midline of the pool, see photograph 28. It is not possible to determine whether just the concrete has cracked, or whether the waterproofing layer below is compromised too. See figure 3 for a detail of the original pool bottom construction. In the East-West direction at the midline of the pool there is a joint between the pavers that has been caulked the full length of the pool, see photograph 29. It is not known whether the waterproofing layer in this area has been compromised as well.

Figure 3: Original pool construction

- Pool cracks: The full extent of cracking in the pool base should be determined as there could be other cracks that are present but less obvious. After determining whether the waterproofing membrane is still intact, the cracks, and membrane if necessary, should be repaired.

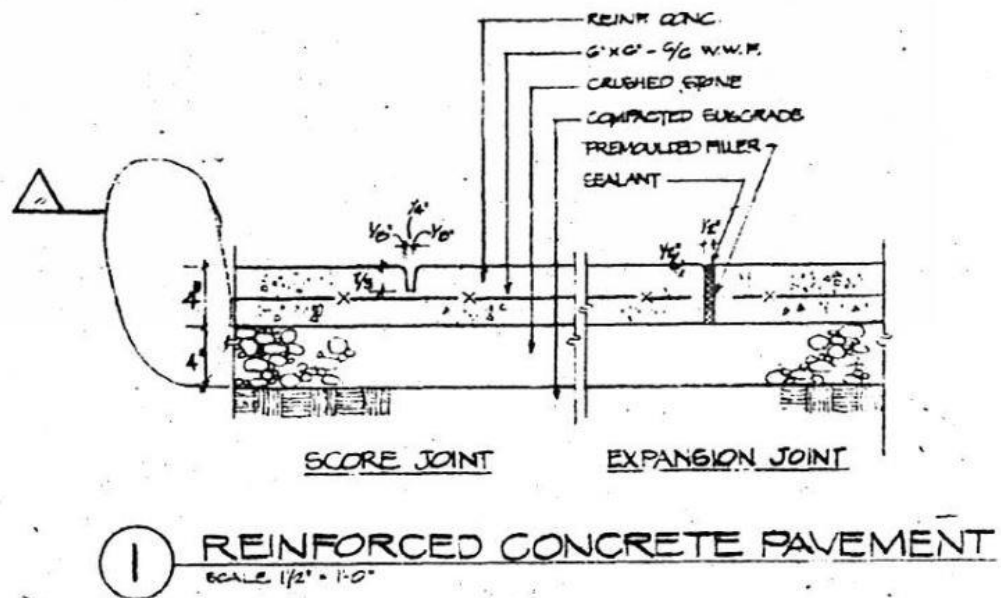
Figure 4: Original reinforced concrete pavement detail, Detail 1, SP-9 in Appendix A

- **Caulked joints:** In any location where the caulk has failed it must be replaced. The type of caulk must be approved and the concrete must be thoroughly prepared per the specifications so the caulk will adhere to the surface, see Figure 4 for the original detail:

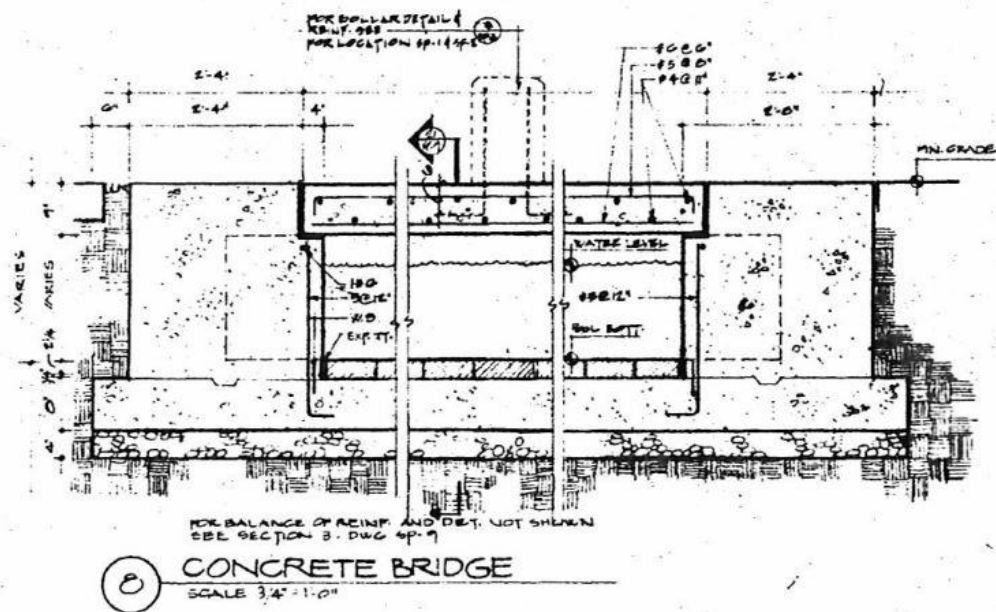
Figure 5: Original detail for reinforced concrete bridge, Detail 8, SP-9 in Appendix A

- Bridges: The deck of each of the two long bridges should be replaced. The deck slab is not cast monolithically with the side walls, Figure 5, (Section 8, Sheet SP-9), so it is anticipated that it should be possible to replace the deck without impacting other components of the bridge.

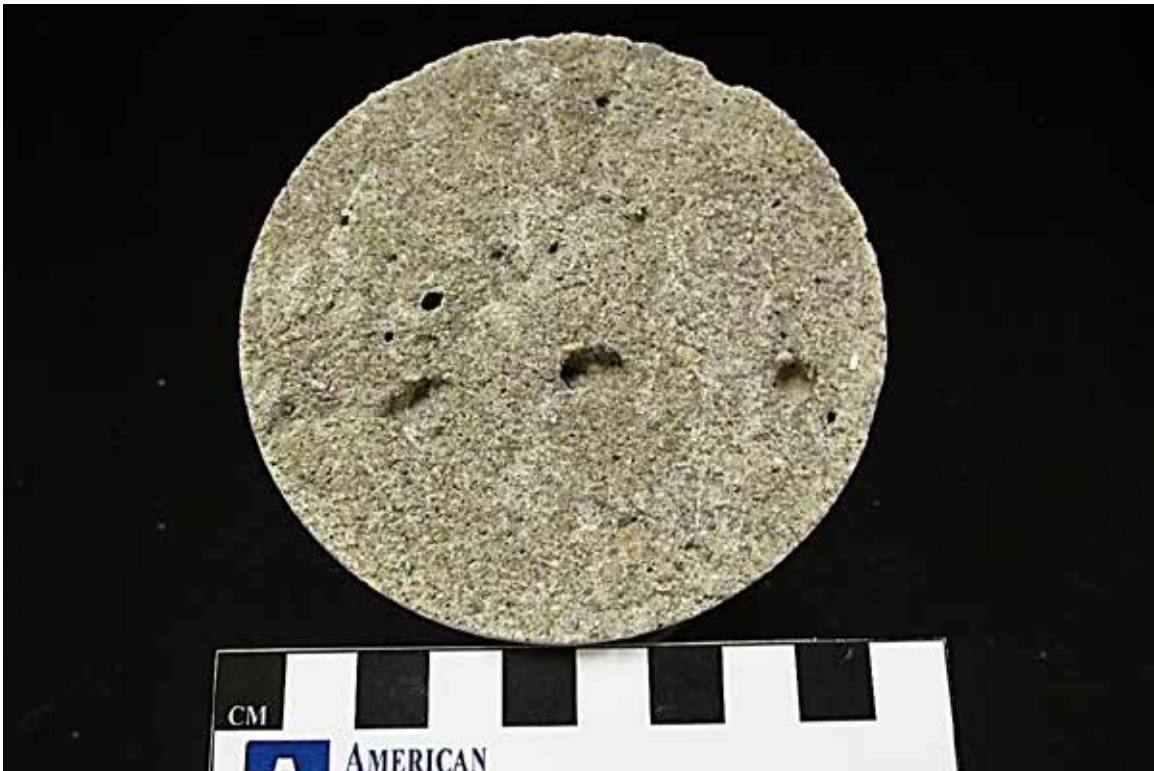
PHOTO: 5

SAMPLE ID: 2 DESCRIPTION: The formed outer surface of the core as received. Minor mortar erosion has exposed many fine aggregate particles.

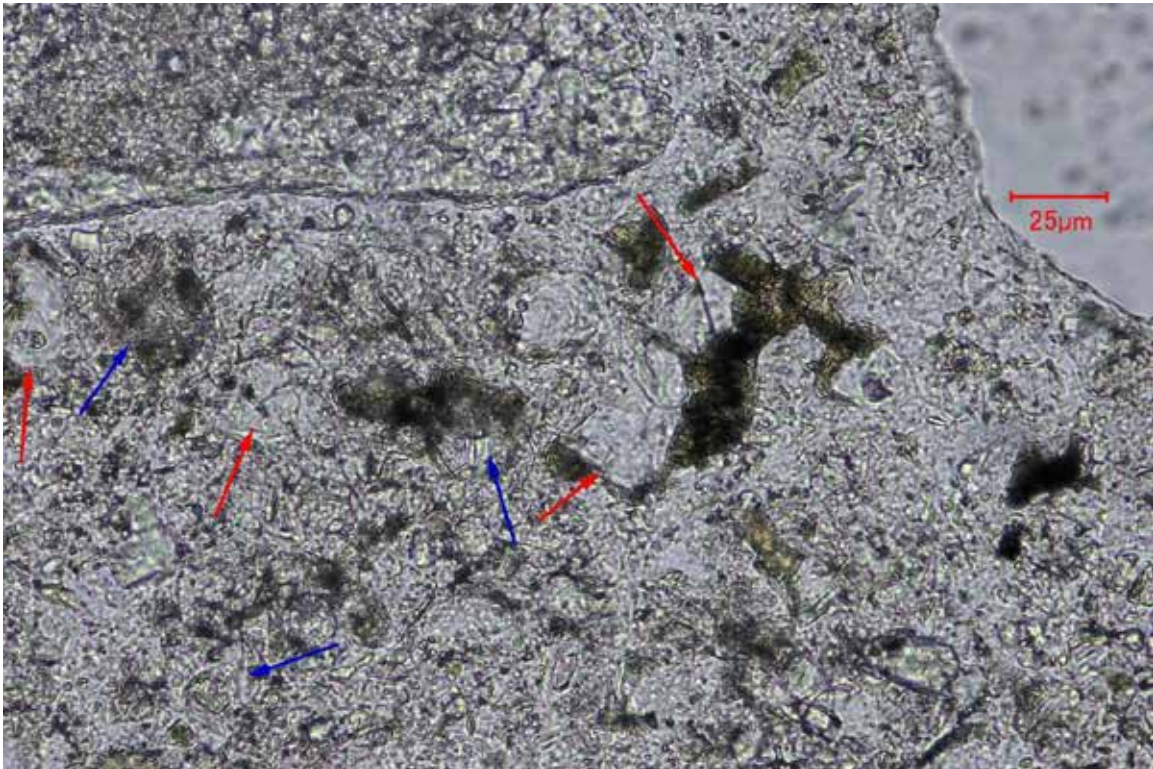
PHOTO: 10

DESCRIPTION: Fully-hydrated relict alite (red arrows) and well hydrated residual belite (blue arrows) portland cement clinker particles in a thin section of concrete paste viewed with transmitted plane-polarized light.
